3.2.9 Upper Bull Run Group Summary

3.2.9.1 Cub Run Watershed

3.2.9.2 Bull Run Watershed

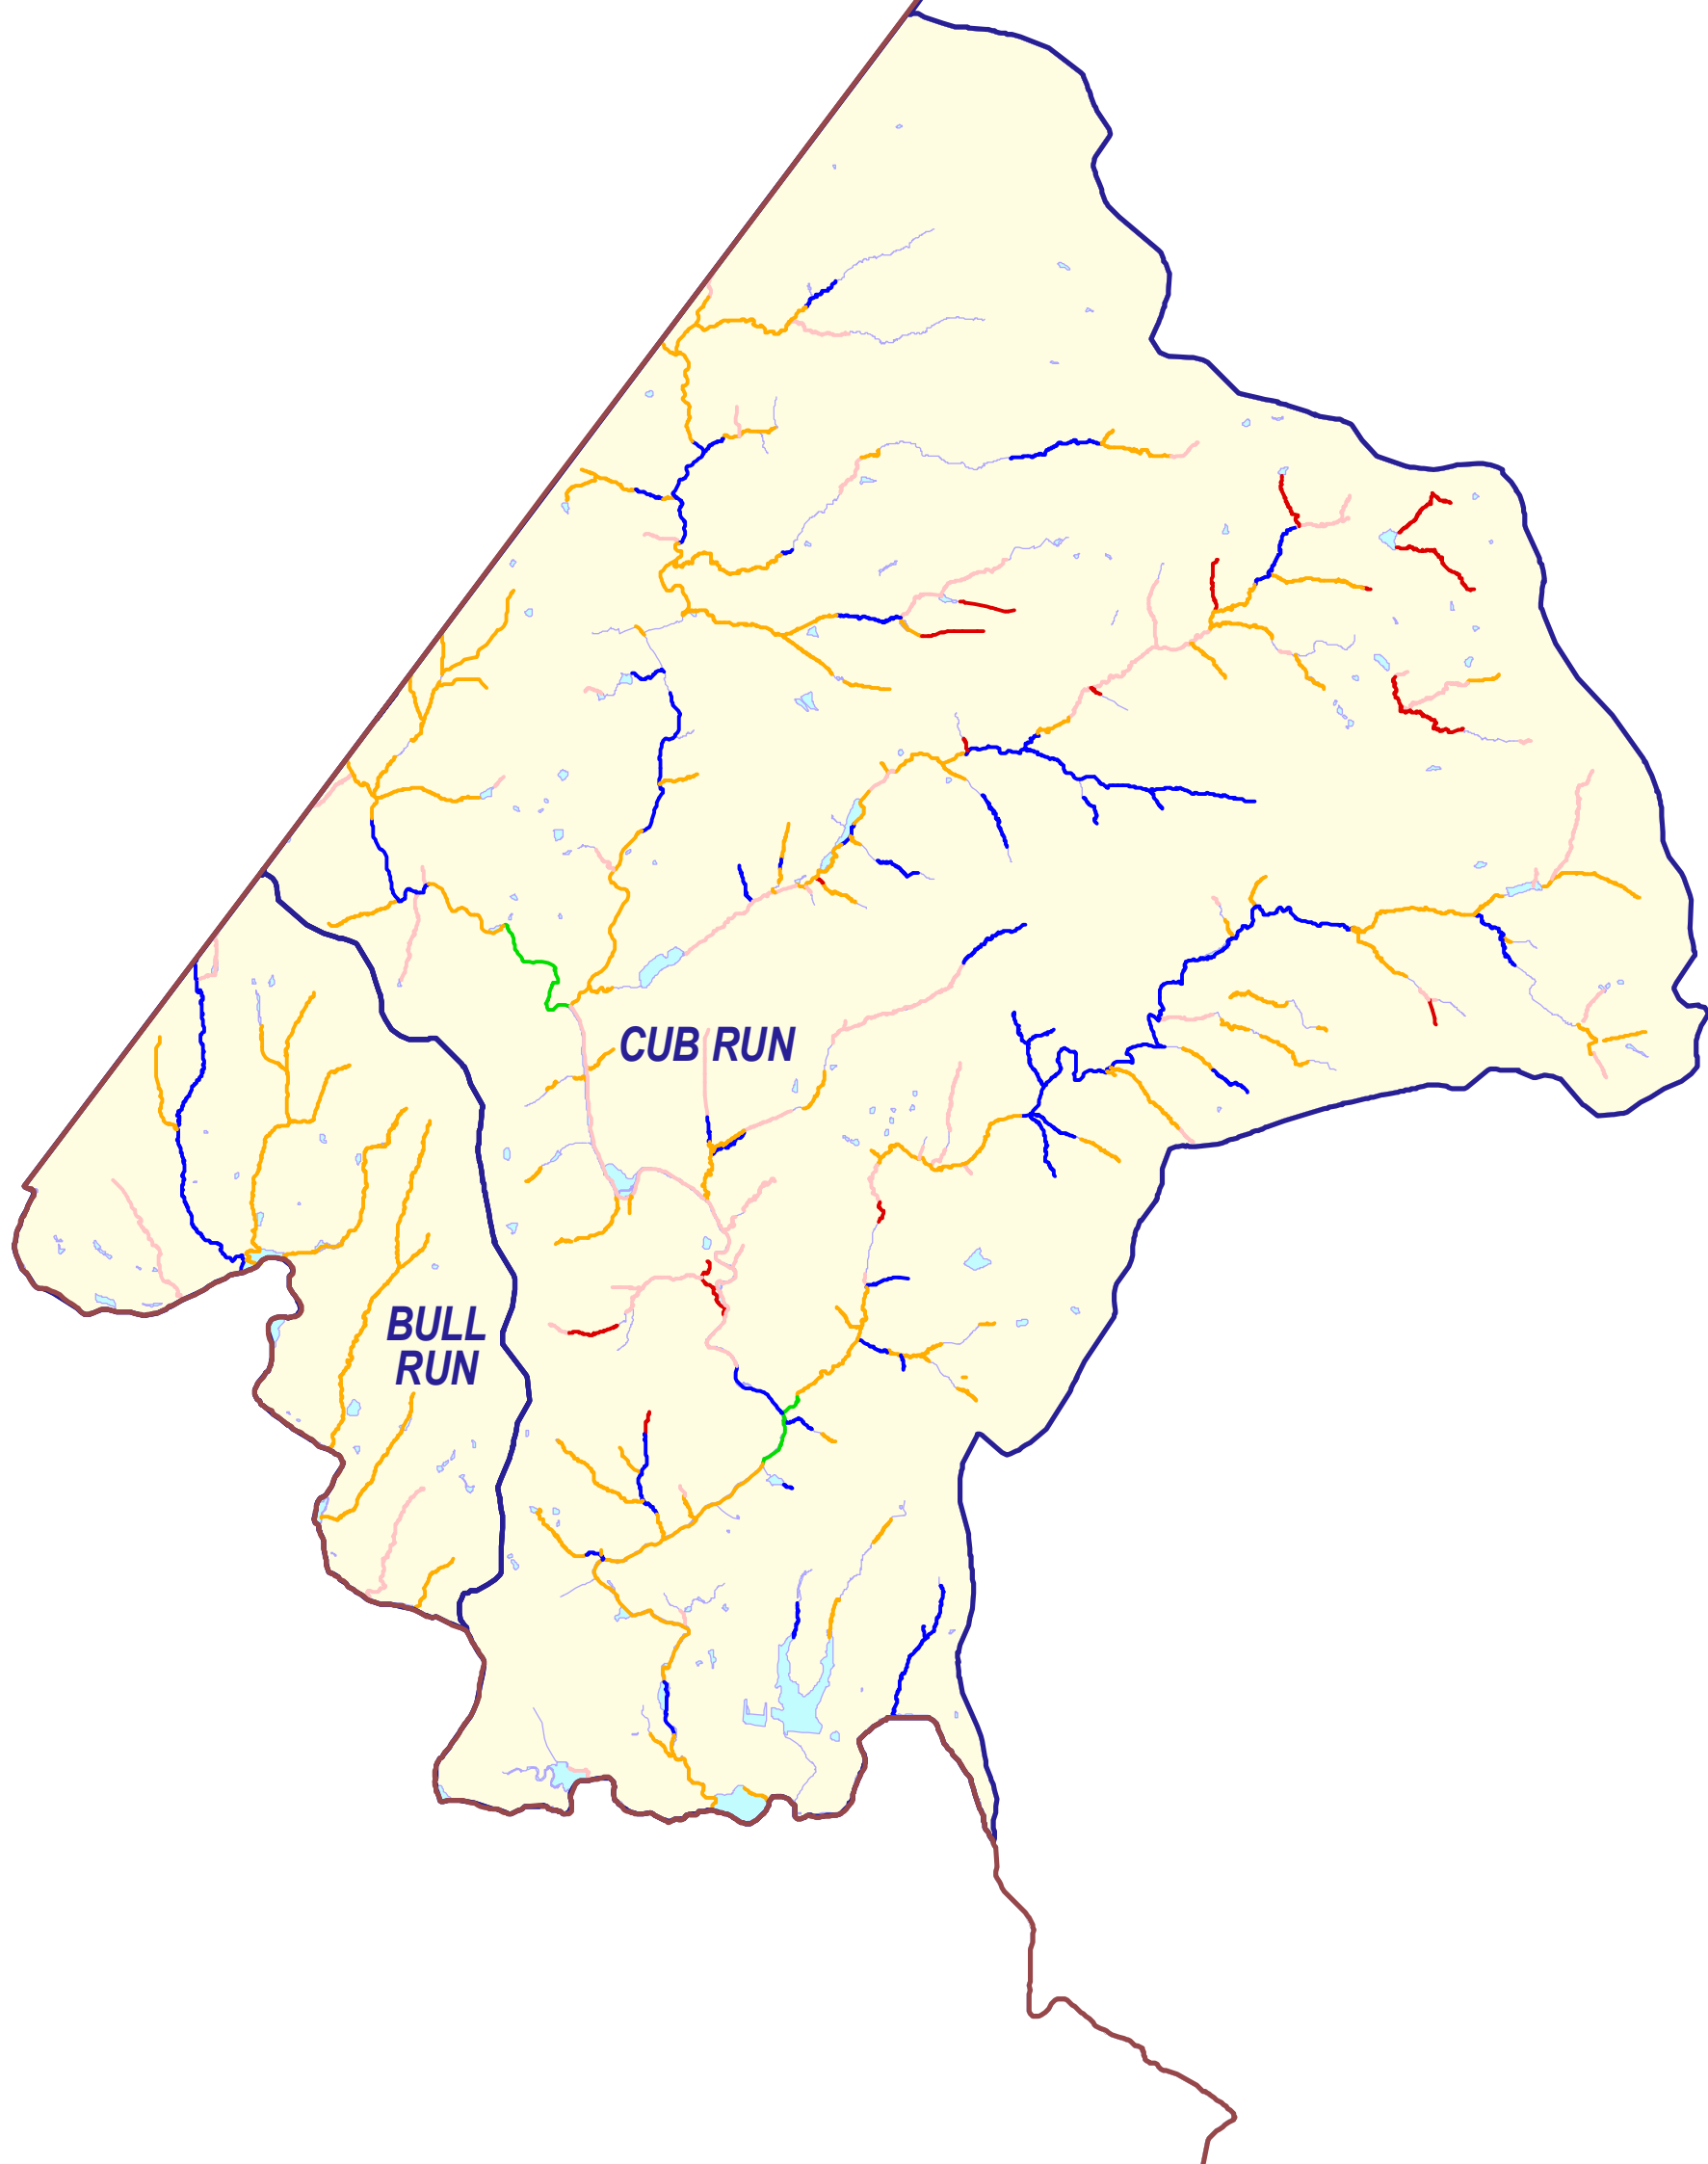
Habitat. The habitat assessment results for Cub Run Watershed are summarized by stream in Table 3-39. Habitat scores for each reach are depicted in Figure 3-59. Based on a length weighted habitat score of 110 (Table 3-2), Cub Run Watershed is in the upper middle range of quality, compared to the rest of the County. Approximately 4.5 mile of stream were categorized as having “very poor” habitat conditions, 17 miles as “poor,” 33 miles as “fair,” and 18 miles as “good” and 1 mile as “excellent.”

Habitat. The habitat assessment results for Bull Run Watershed are summarized by stream in Table 3-41. Habitat scores for each reach are depicted in Figure 3-59. Based on a length weighted habitat score of 108 (Table 3-2), Bull Run Watershed is in the upper middle range of quality, compared to the rest of the County. Approximately 2 miles of stream was categorized as having “poor” habitat conditions, 9 miles as “fair,” and 2 miles as “good.”

Figure 3-59
Habitat Assessment
Upper Bull Run Group
Fairfax County Stream Physical Assessment

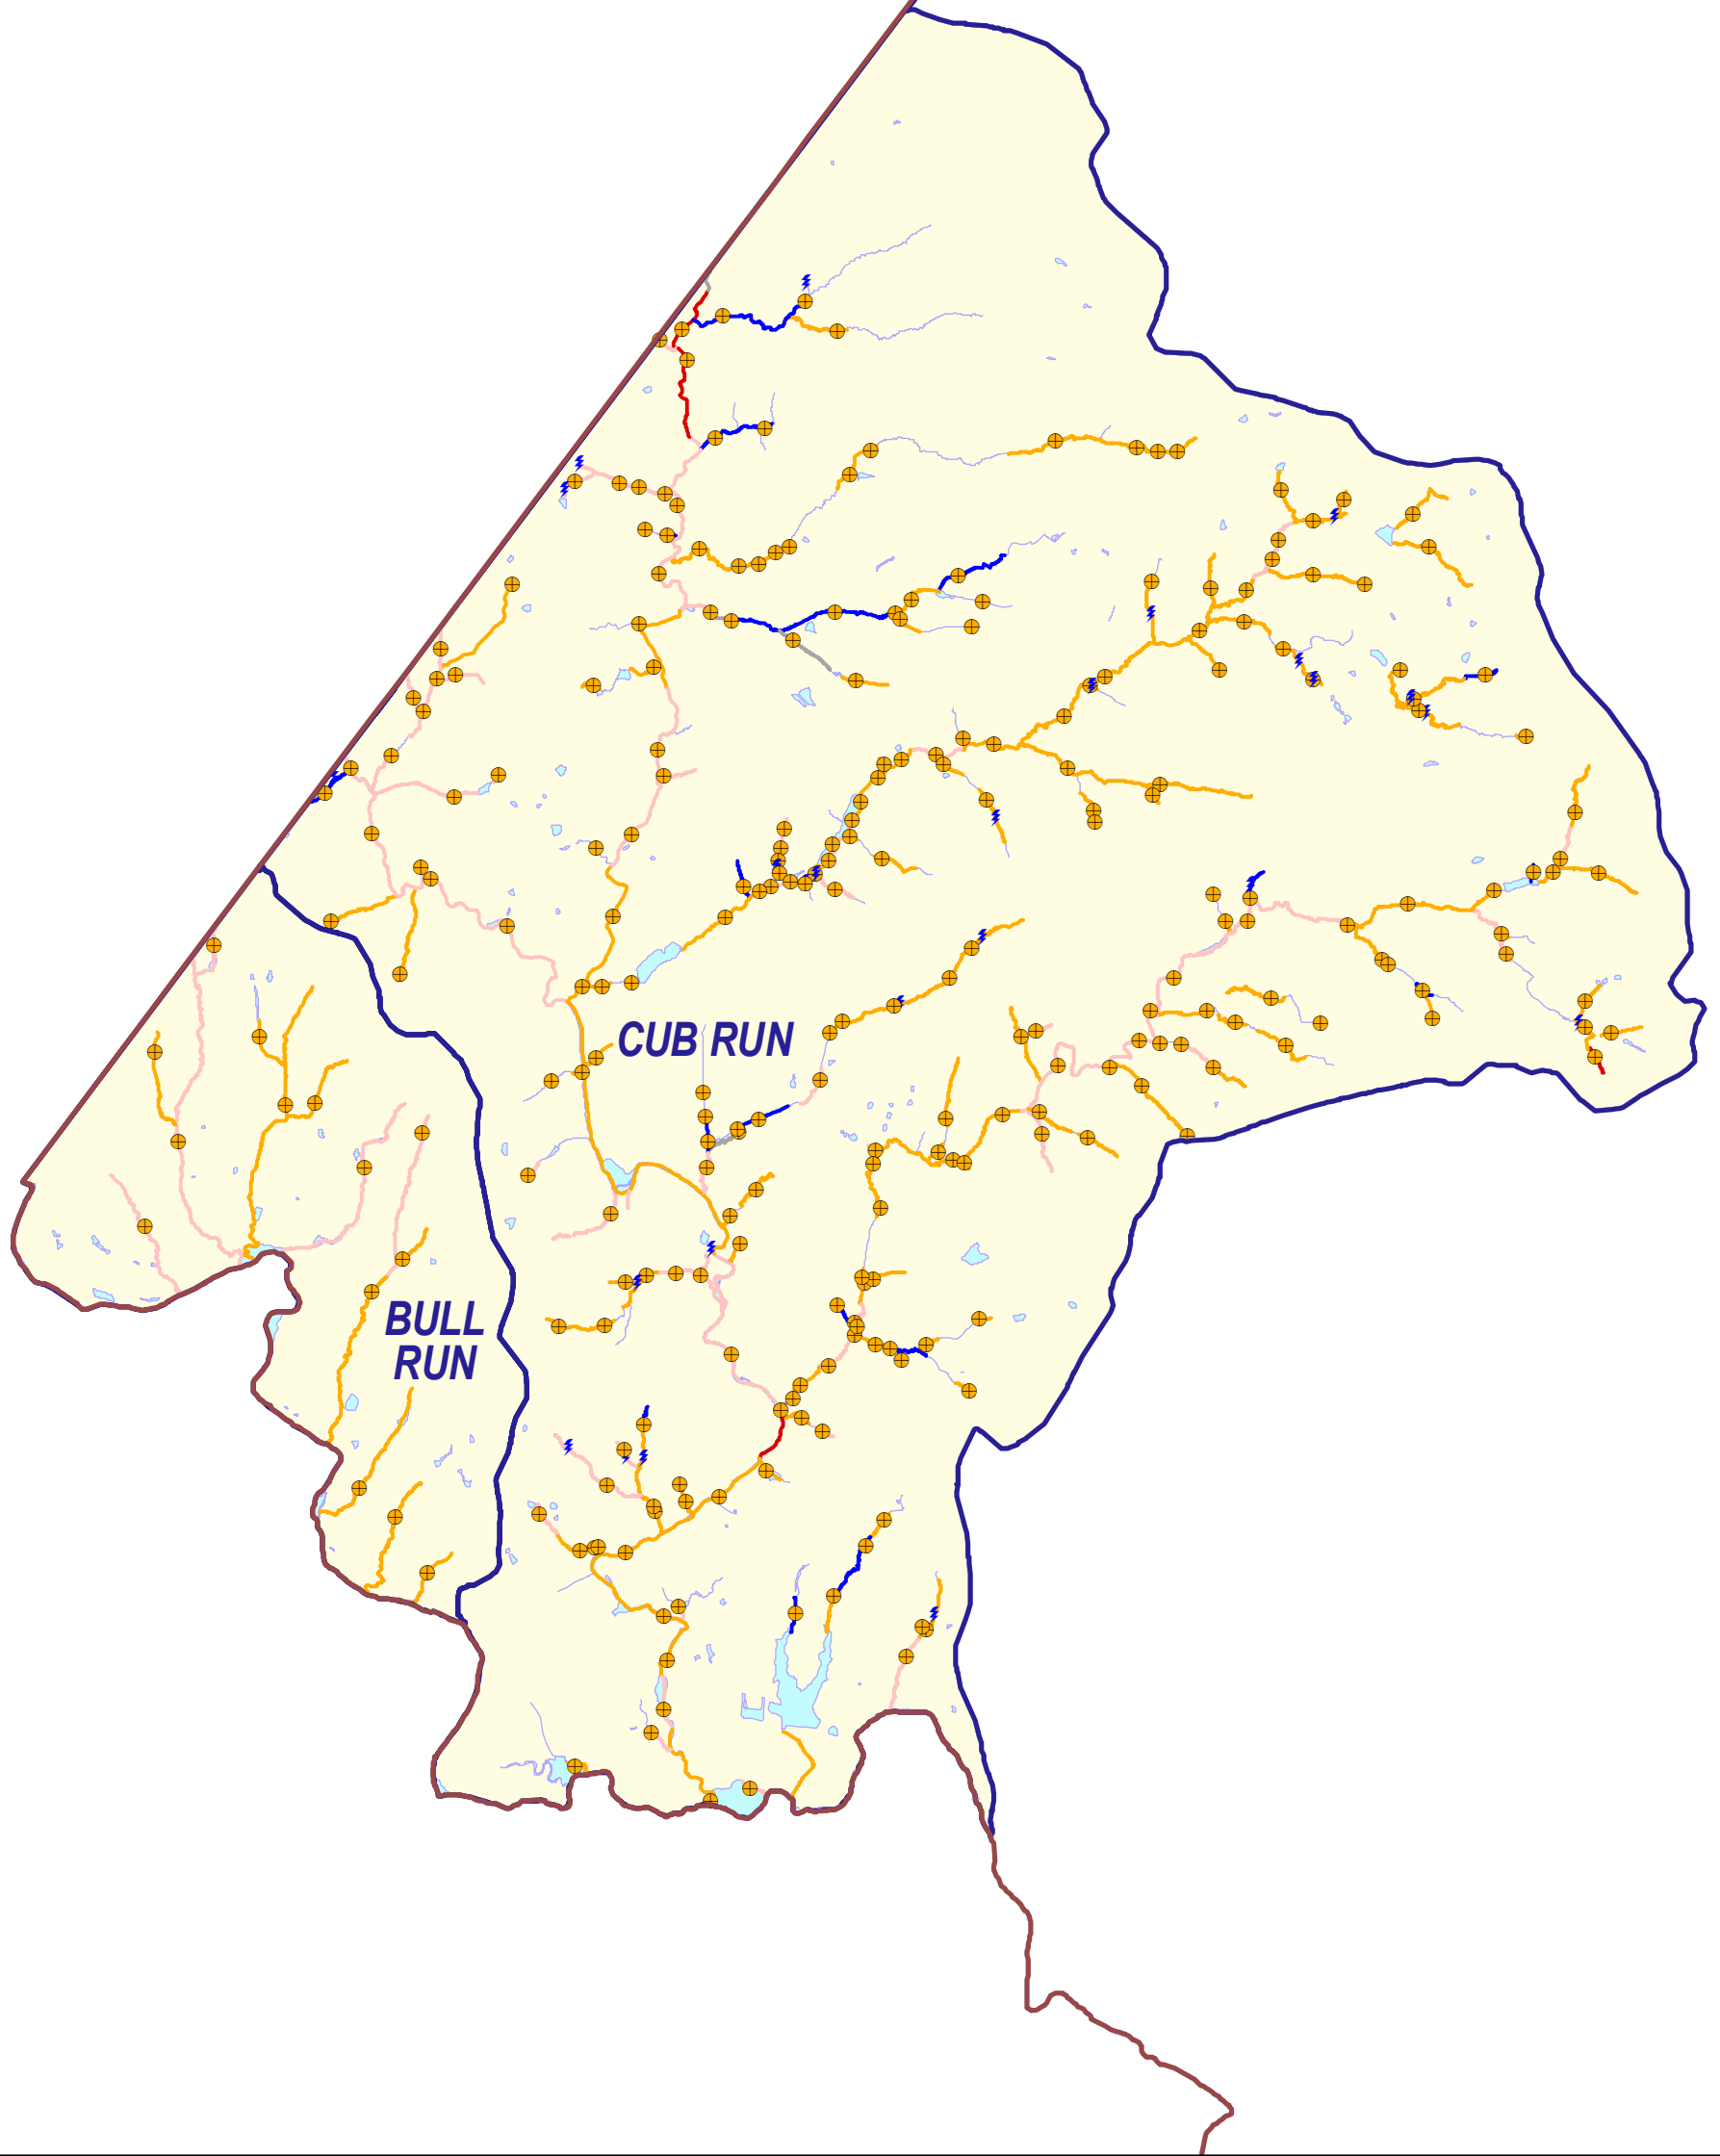
CEM. Based on the CEM evaluations approximately 60 percent of the channels assessed in Cub Run Watershed are in Evolutionary Stage 3 (Table 3-3) and most of the rest are in Stage 4. Figure 3-60 summarizes the CEM results for Cub Run Watershed.

CEM. Based on the CEM evaluations approximately two thirds of the channels assessed in Bull Run Watershed are in Evolutionary Stage 3 (Table 3-3) with the remainder in Stage 2. Figure 3-60 summarizes the CEM results for Bull Run Watershed.

Figure 3-60
CEM Stages
Upper Bull Run Group
Fairfax County Stream Physical Assessment

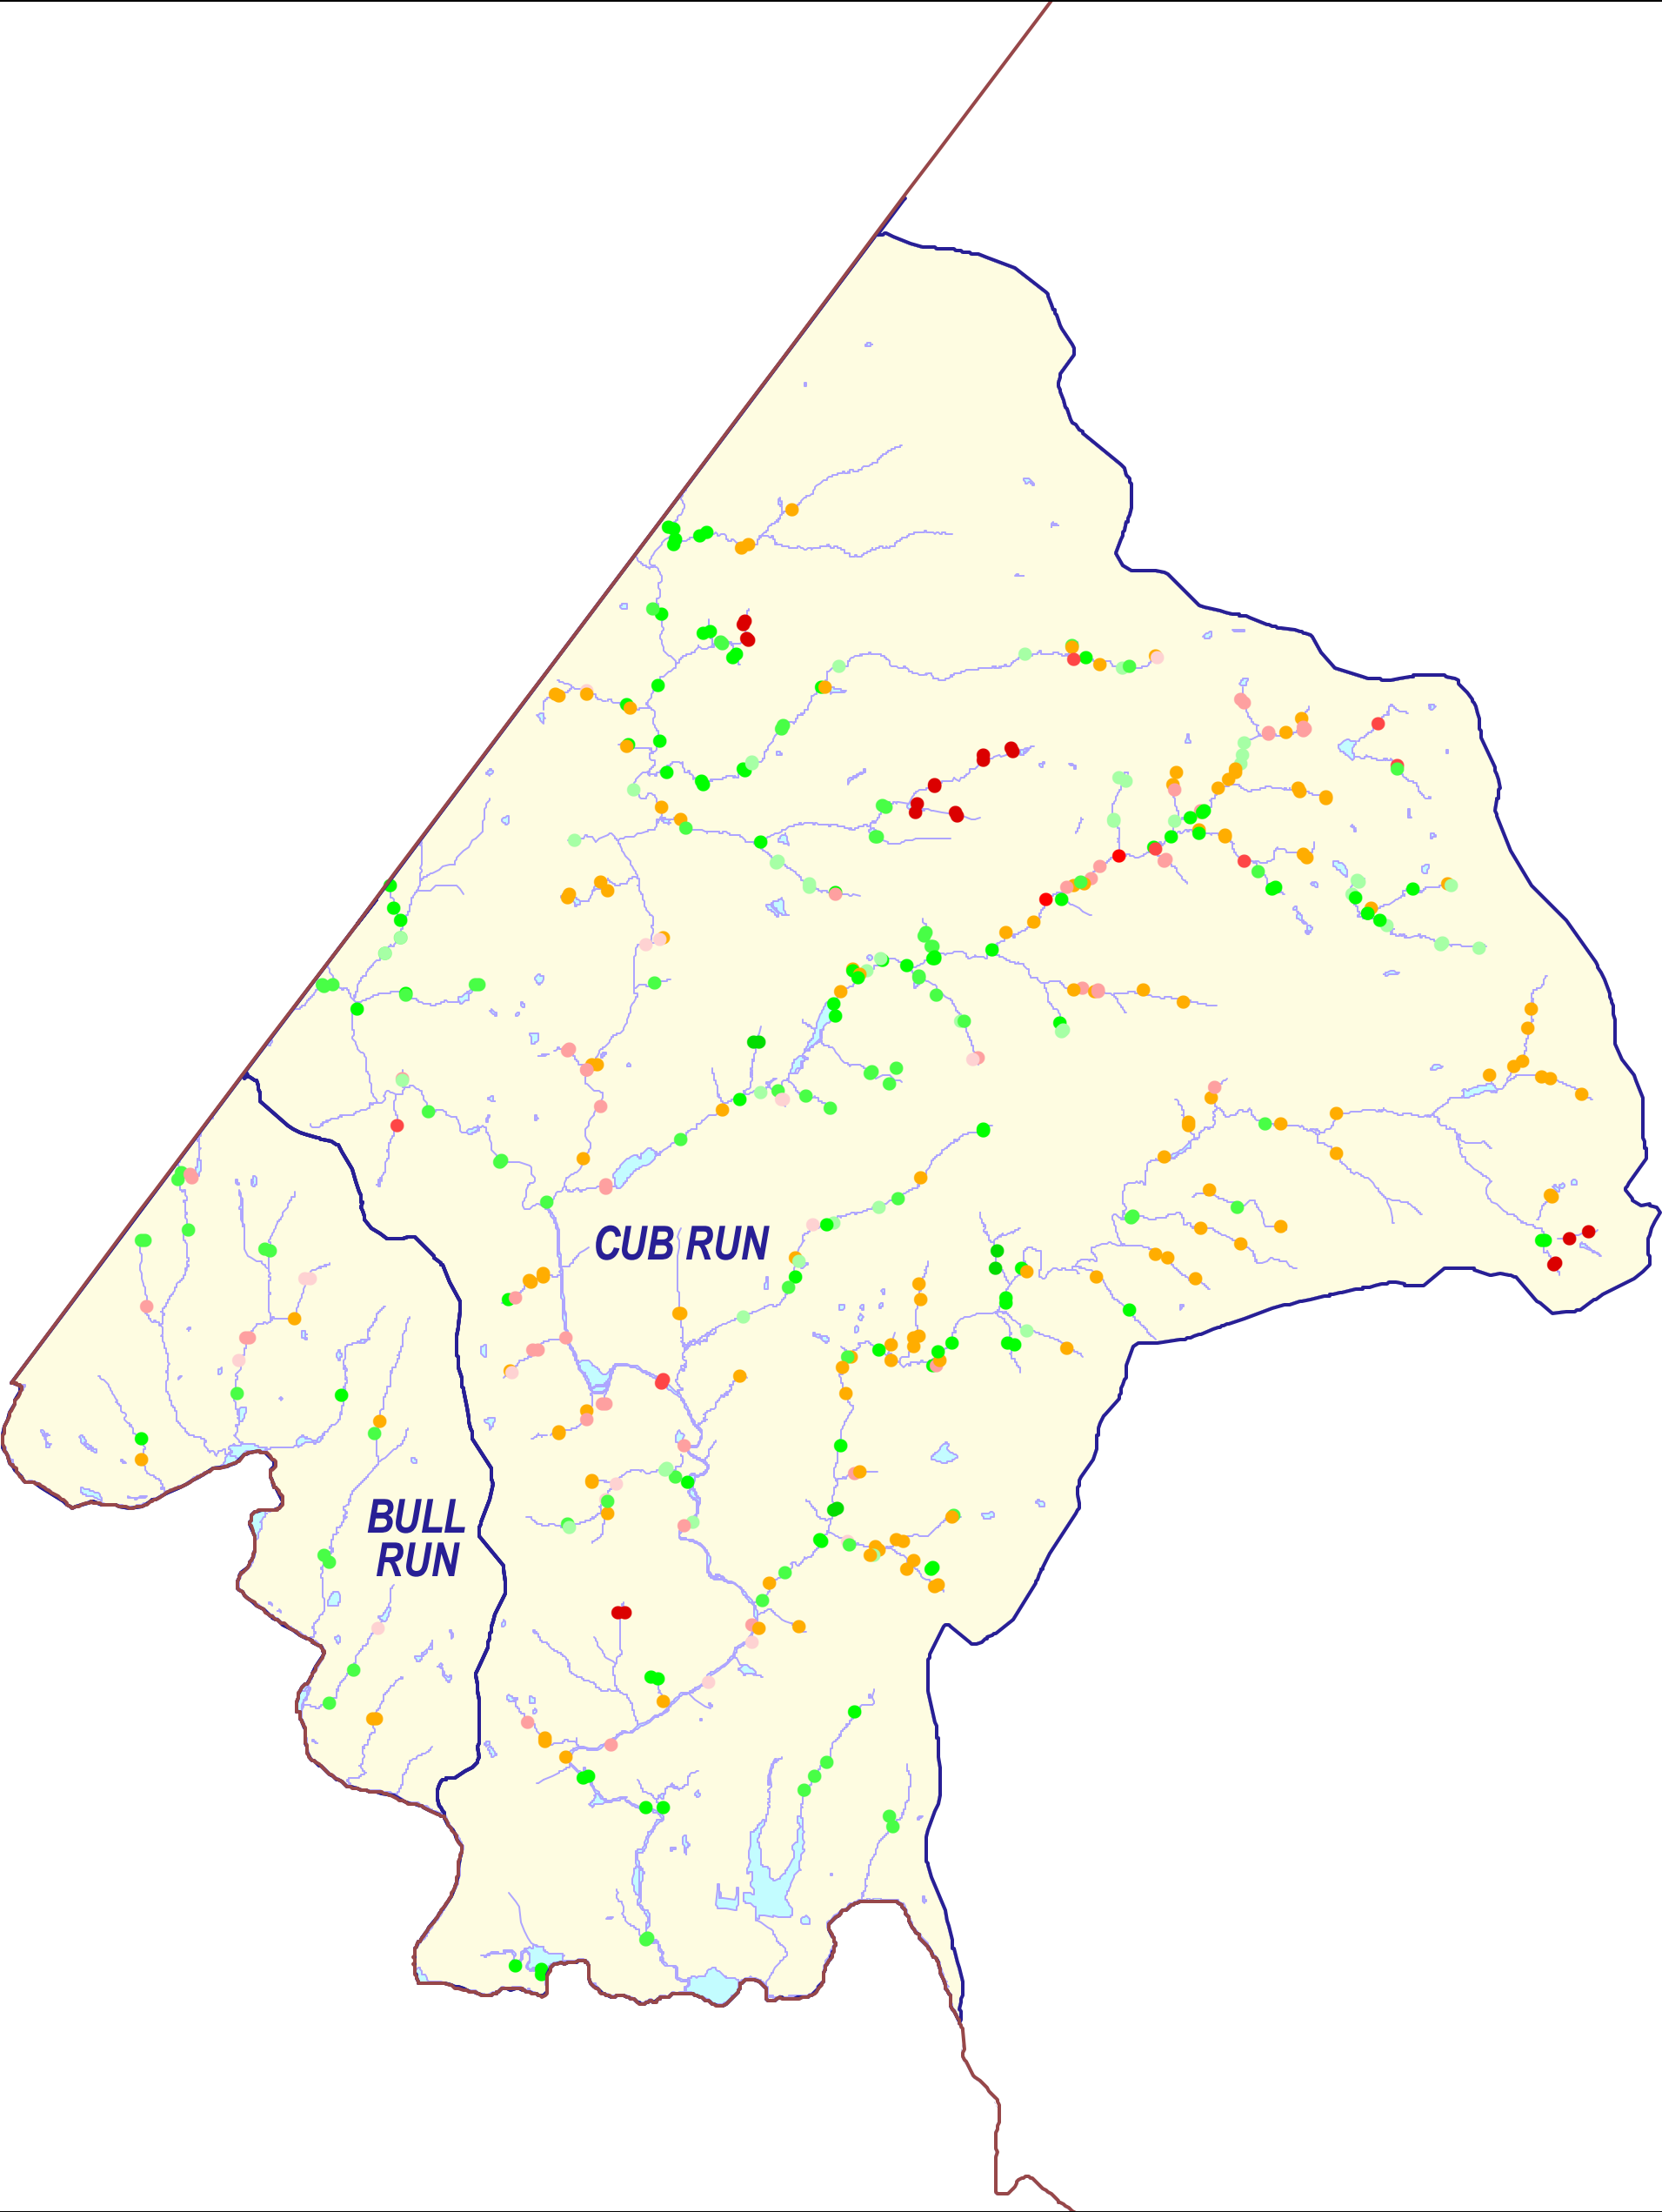
Infrastructure. The infrastructure inventory resulted in 1473 inventory points. The most significant problem was related to 20 deficient buffers as well as a variety of other infrastructures with an impact score of 10. Figures 3-61, 3-62, 3-63, 3-64, and 3-65 summarize impact scores for the erosion problems; deficient buffers; crossings; pipes/ditches; and dumps, obstructions, and utilities, respectively.

Figure 3-62
Deficient Buffer Impacts
Upper Bull Run Group
Fairfax County Stream Physical Assessment

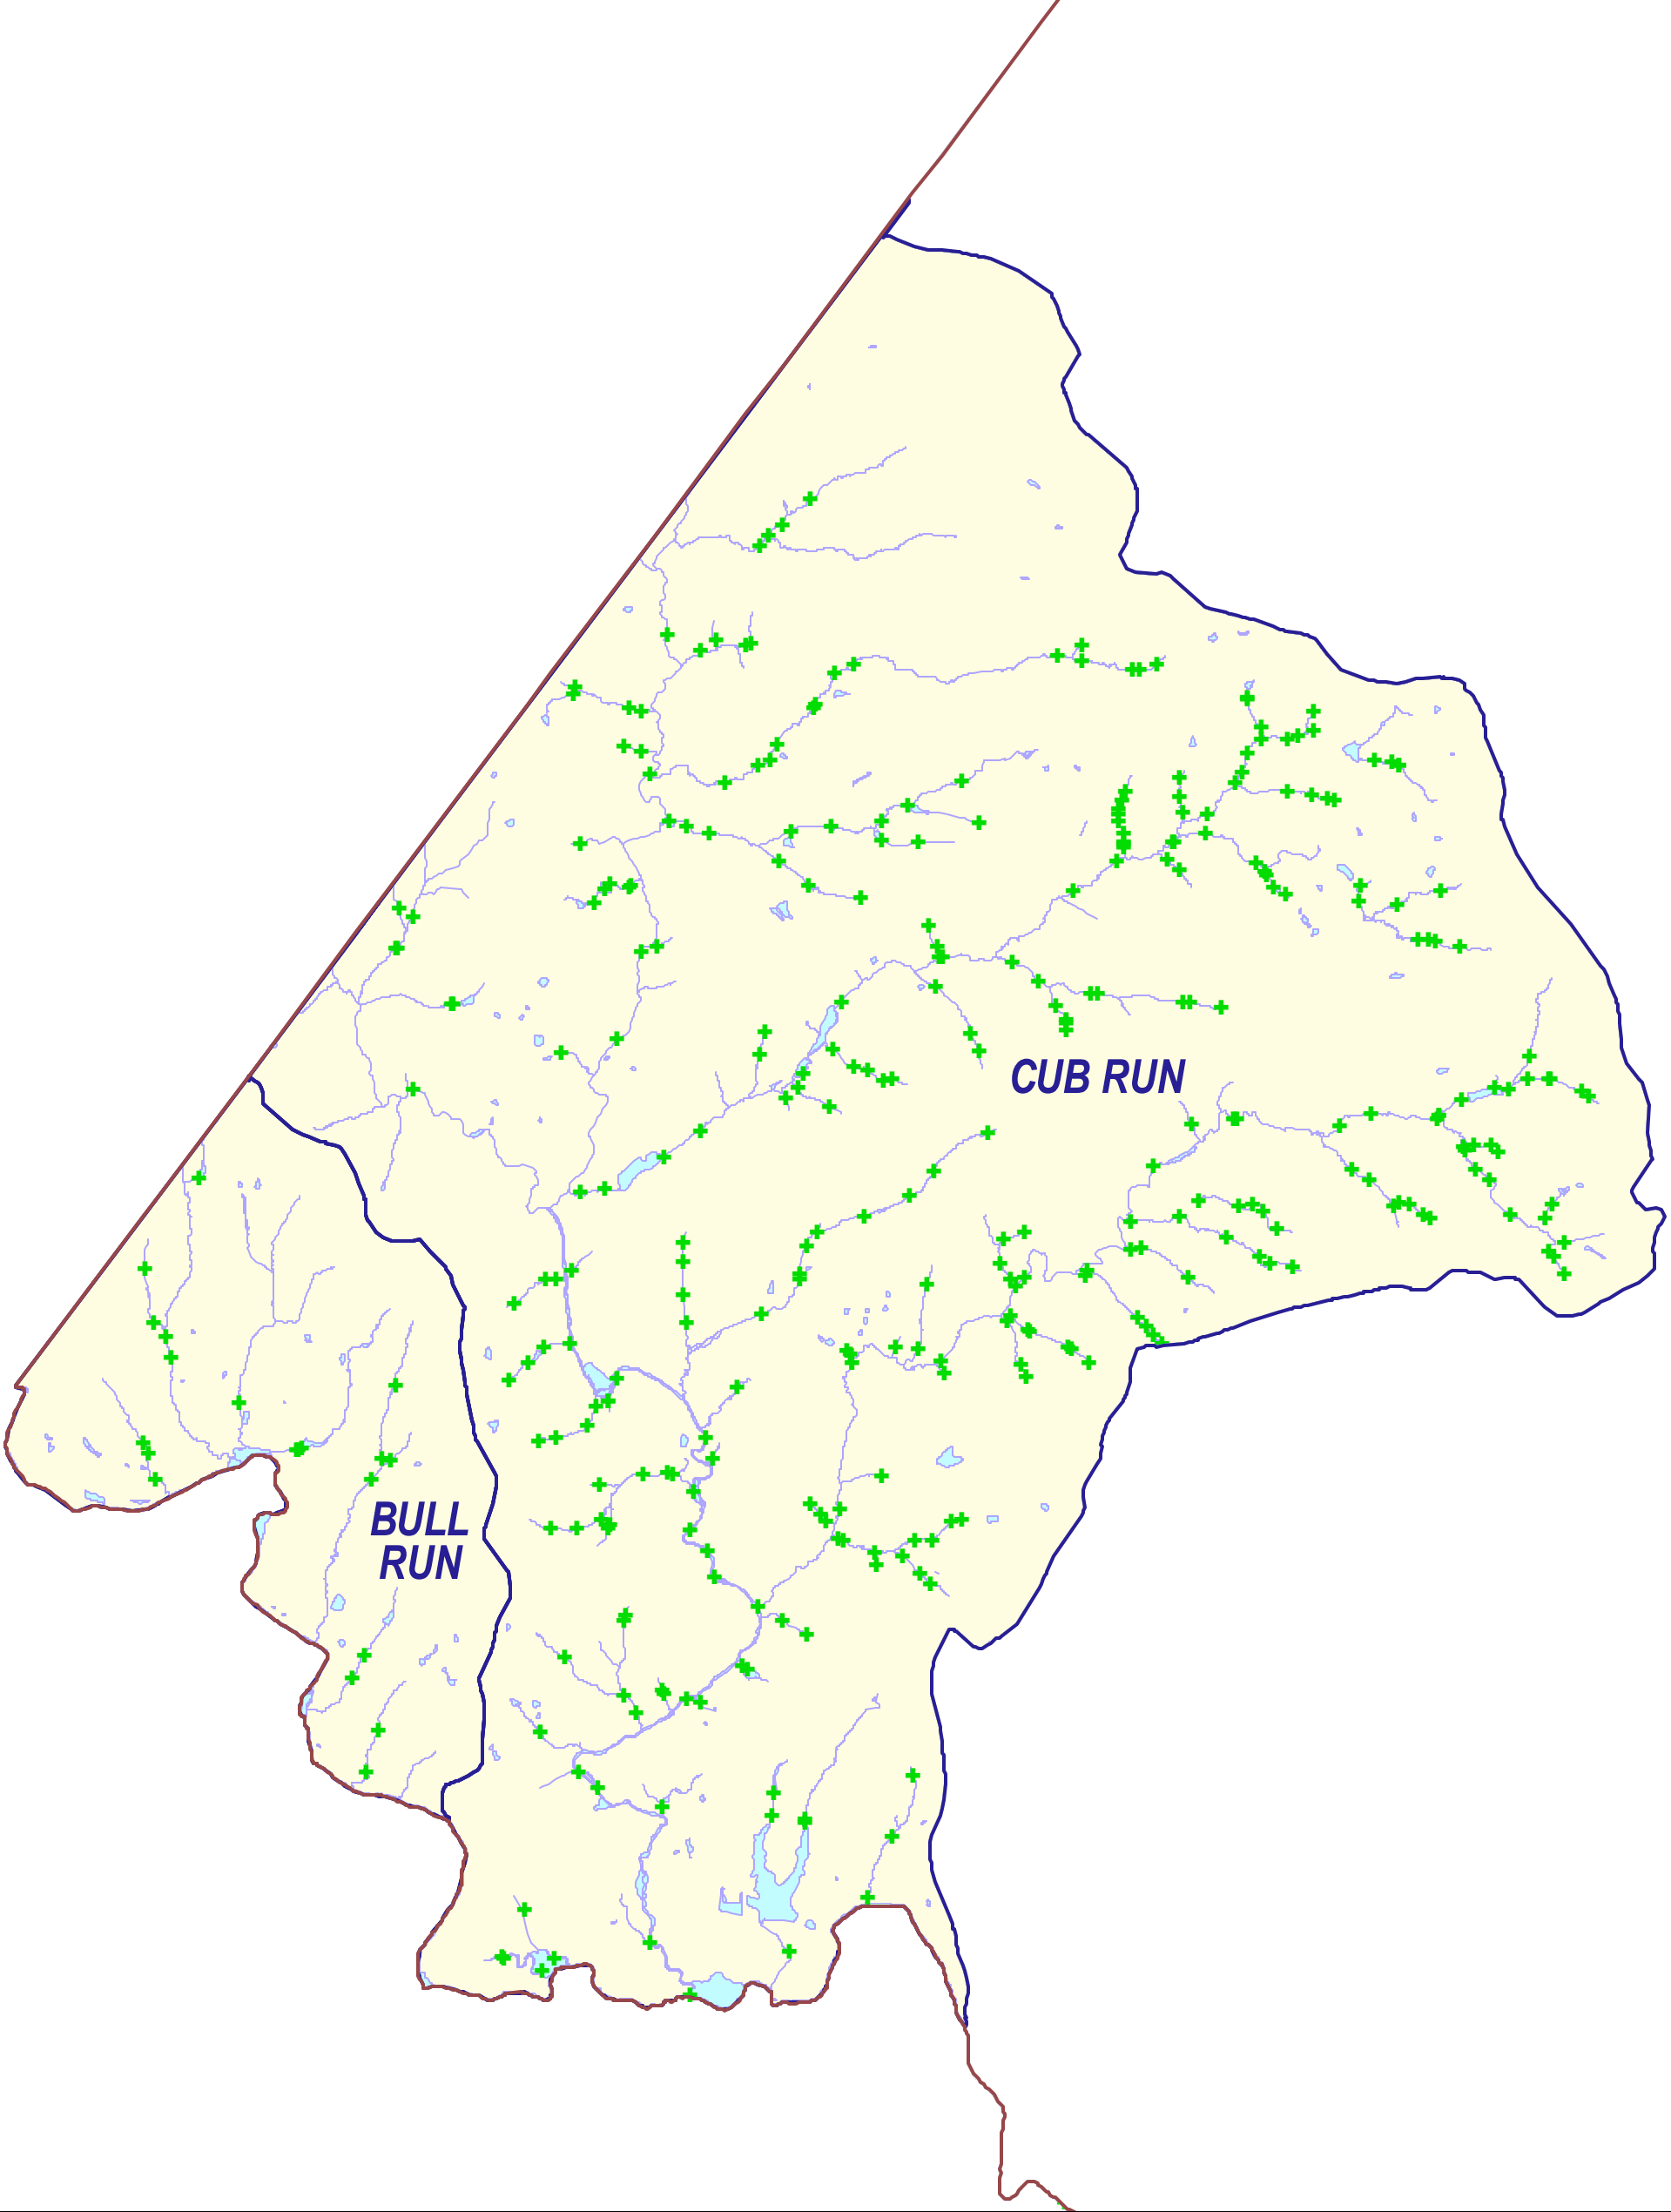
**Figure 3-63
Crossings
Upper Bull Run Group
Fairfax County Stream Physical Assessment**

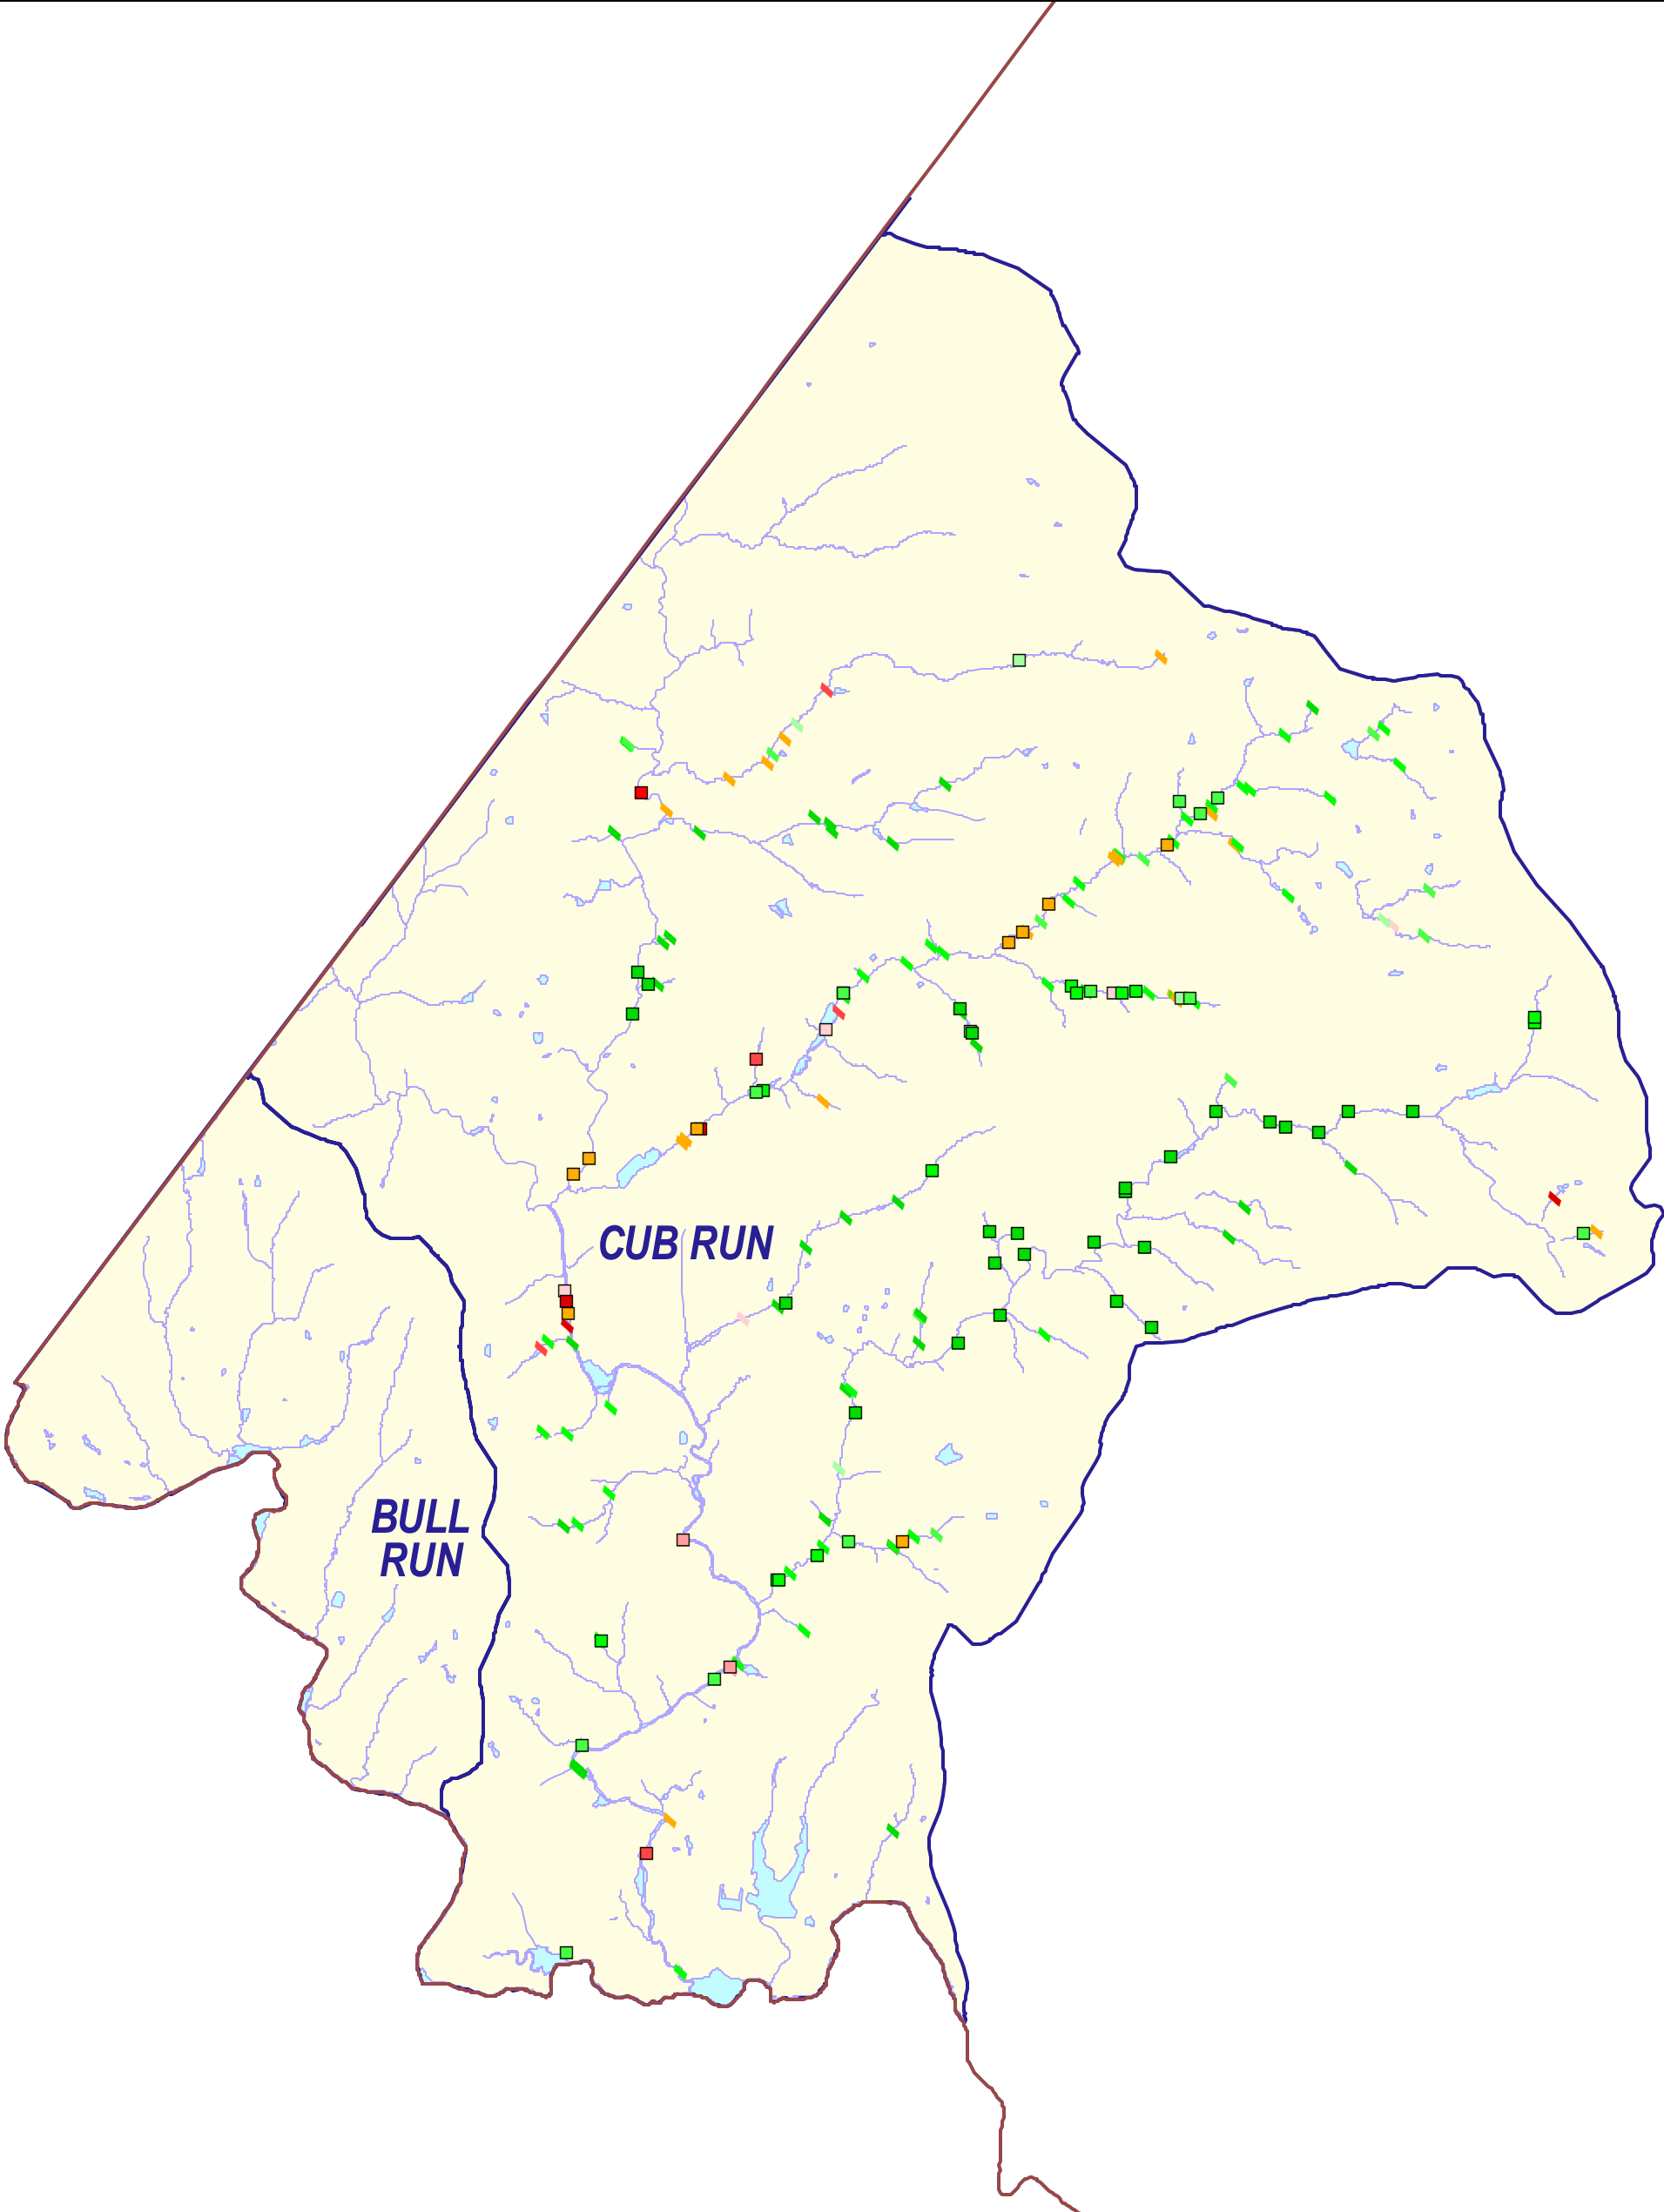
Figure 3-64
Pipe and Ditch Impacts
Upper Bull Run Group
Fairfax County Stream Physical Assessment

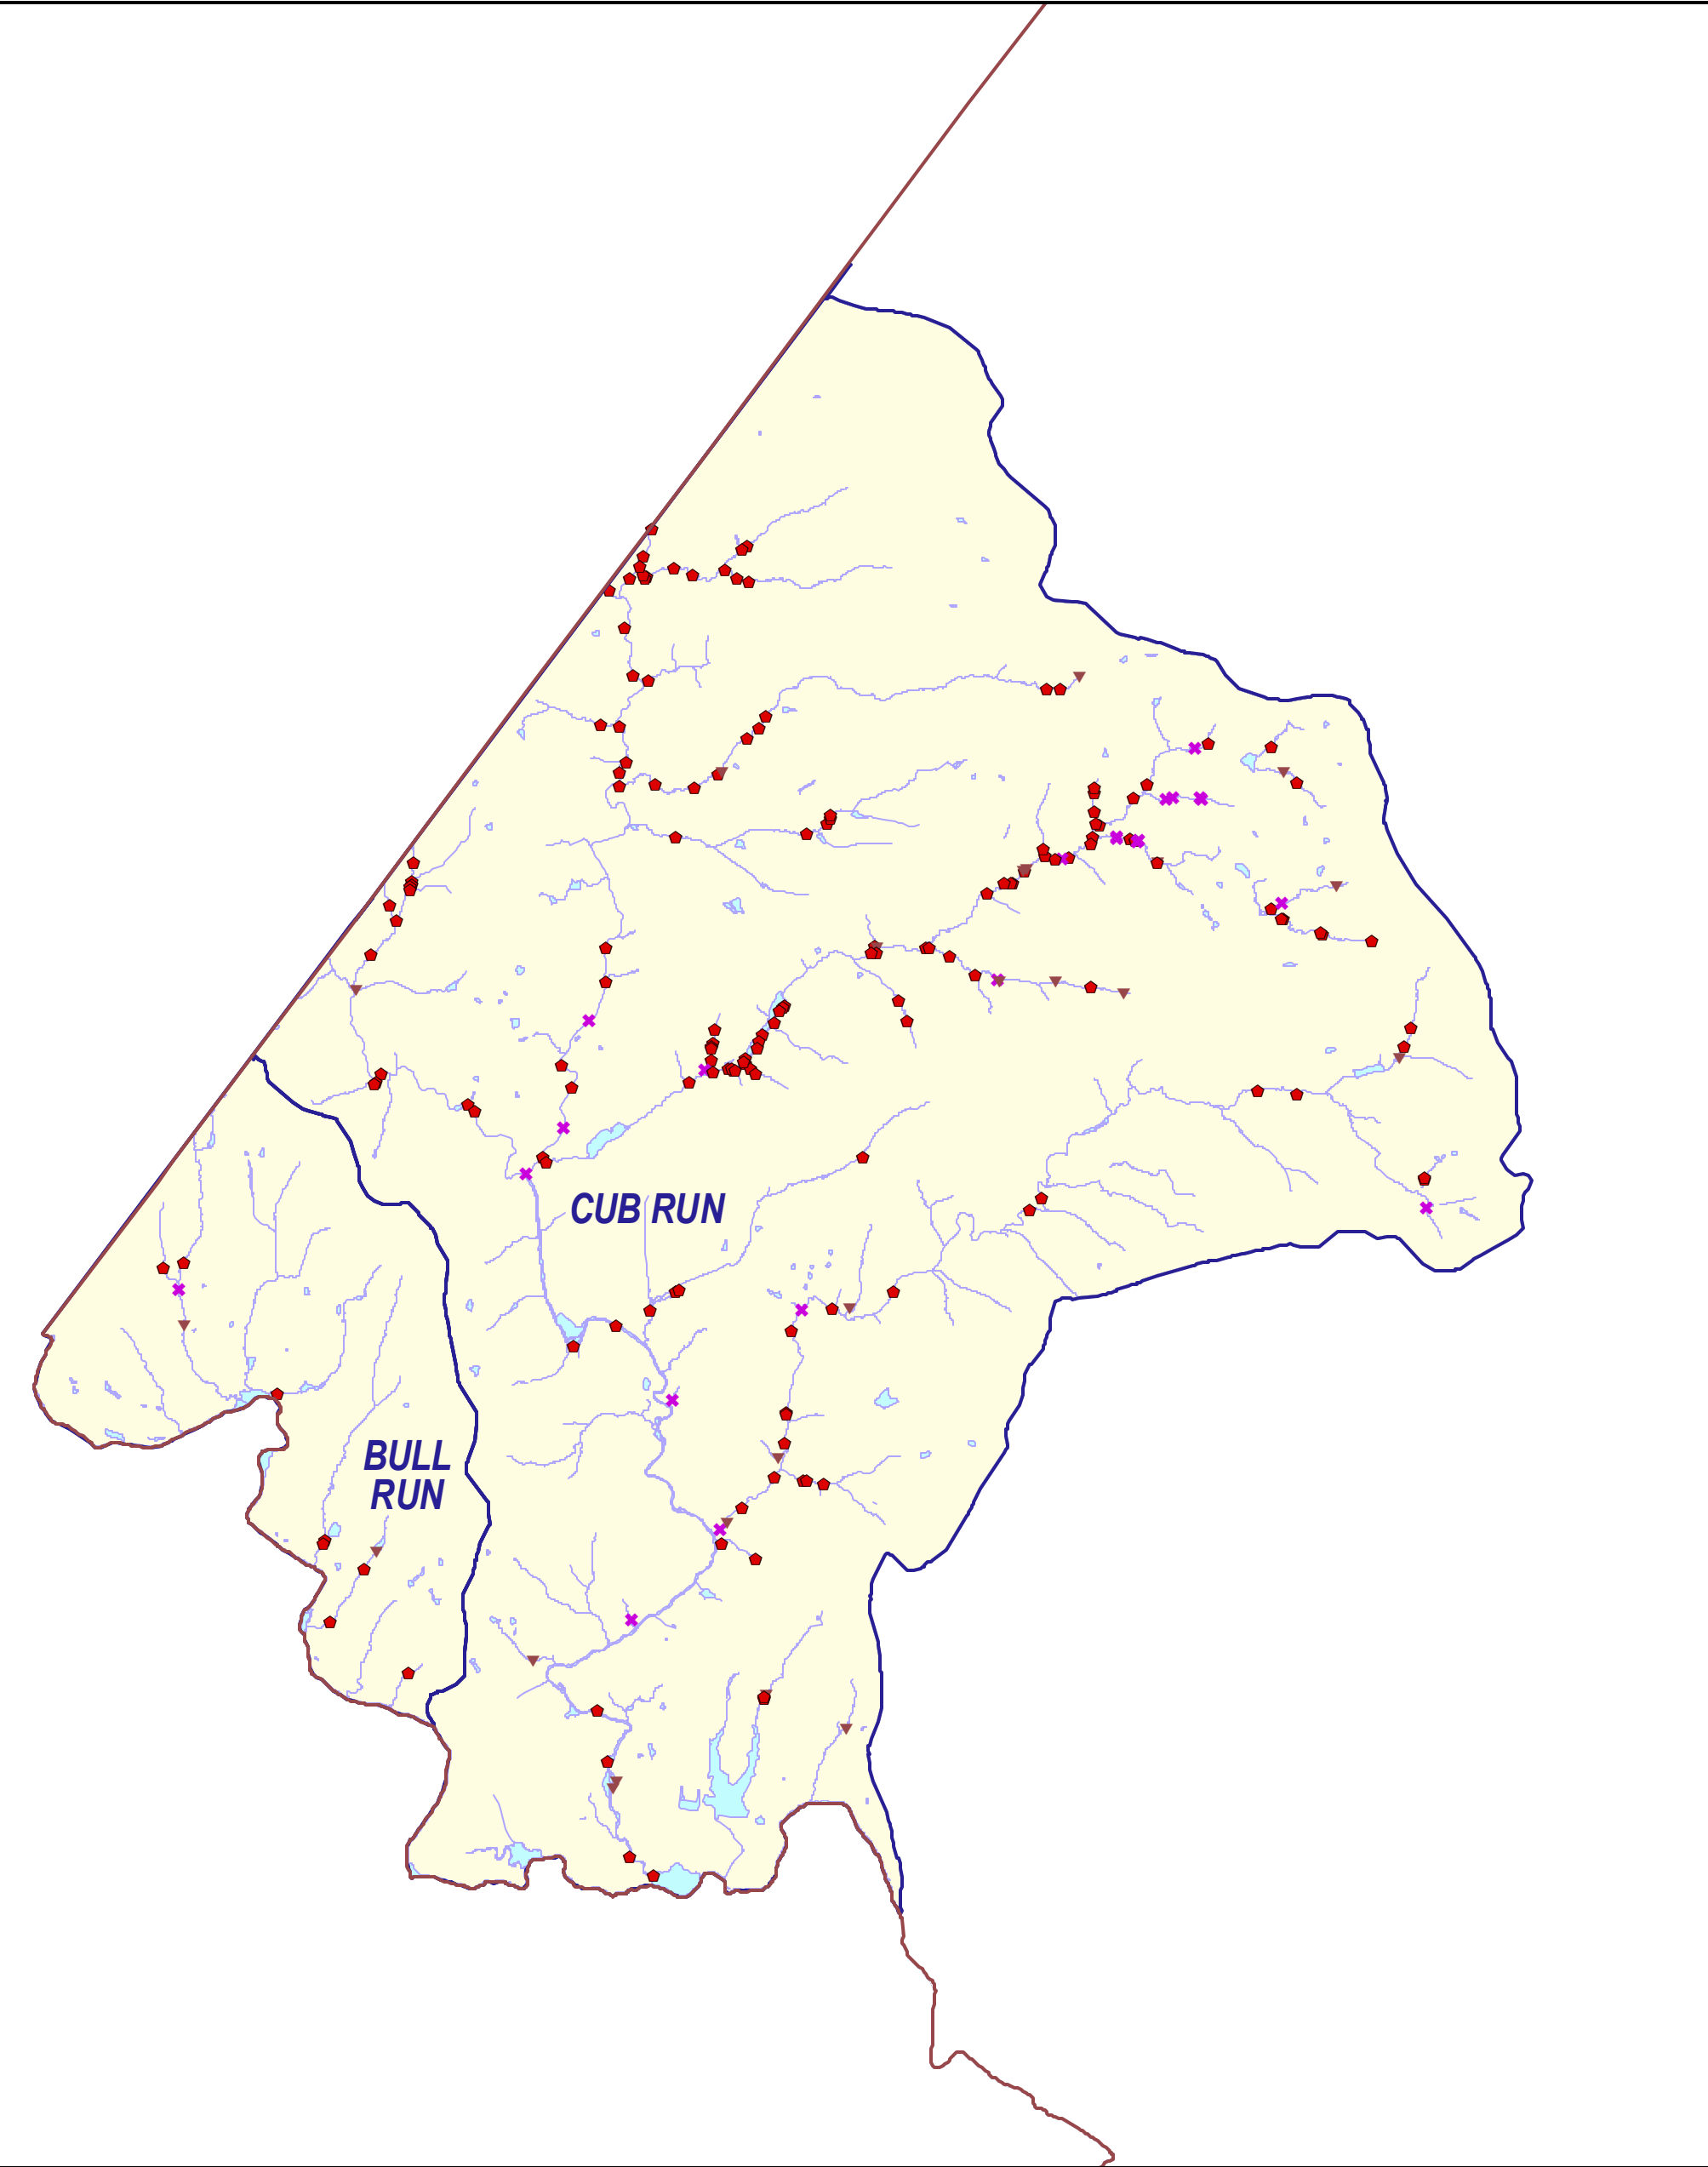
Figure 3-65
Dumps, Obstructions, and Utilities
Upper Bull Run Group
Fairfax County Stream Physical Assessment
